Surgical management of bilateral mandibular fracture in Buffalo

RK Gosai, AN Patel, JB Patel, PT Sutaria and Abhishek M Patel

Bilateral mandibular fracture was presented in 4 years old buffalo due to accidental injury. Radiographically the fracture was seen at the proximal one third of horizontal ramus of mandible. The fracture was stabilized with bilateral intramedullary pinning. Bilateral fracture in buffalo can be well managed with intramedullary pinning.

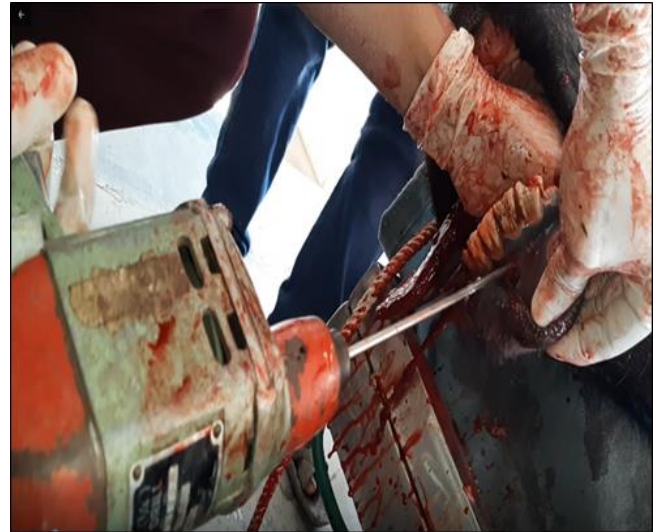
Fig 3: Intramedullary pinning

The head of buffalo was elevated on wooden stool covered with sterile drape (fig.2). The reduction of fracture was performed with steady traction on lower jaw and was manually held in proper position of occlusion. The normograde intramedullary pinning was done using 5 mm diameter Steinmann pin, by passing in between 2nd and 3rd incisor teeth on both sides (fig.3). The pin was passed up to the root of first premolar and hammered in place followed by cutting of extra pin portion. The post-operative radiograph was taken in lateral recumbency and it's observed that slight malalignment of fractured bone because of the less palpable space for distal fragment (fig.4). The lacerated mucosa was sutured with chromic catgut no.1 by continuous lock stitch pattern. Post-operatively, Inj. Dicrysticin (Streptopenicillin) 5 gm total dose, Inj. Melonex (Meloxicam) 0.2 mg/ kg b. wt. and Inj. Clomet (Chlorpheniramine Maleate) 15 ml total dose intramuscularly was given for five days. Daily antiseptic dressing with dilute Povidone iodine was performed by flushing at fracture and pin entry site till complete mucosal healing. Lower mandible was supported with card board for minimum movement of fracture. The owner was advised for only liquid feeding up to one week, followed by semi-solid diet for another 15 days along with *adlibitum* watering. The buffalo has started normal feeding after 21 days of surgery without any complications (fig.5).

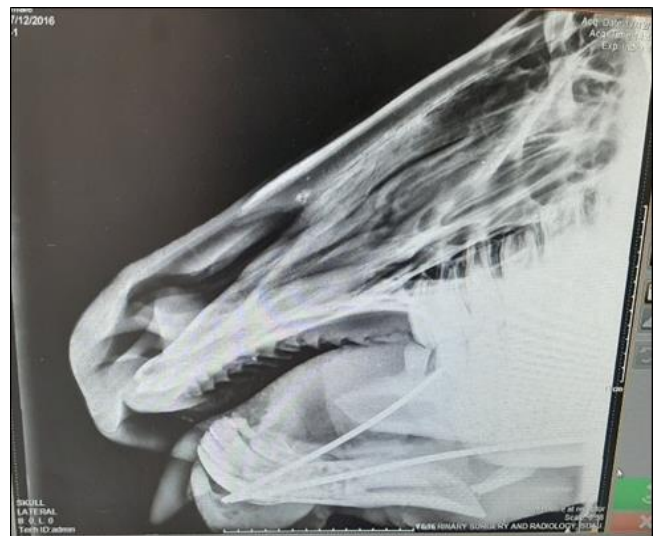
Fig 4: Radiograph after pinning

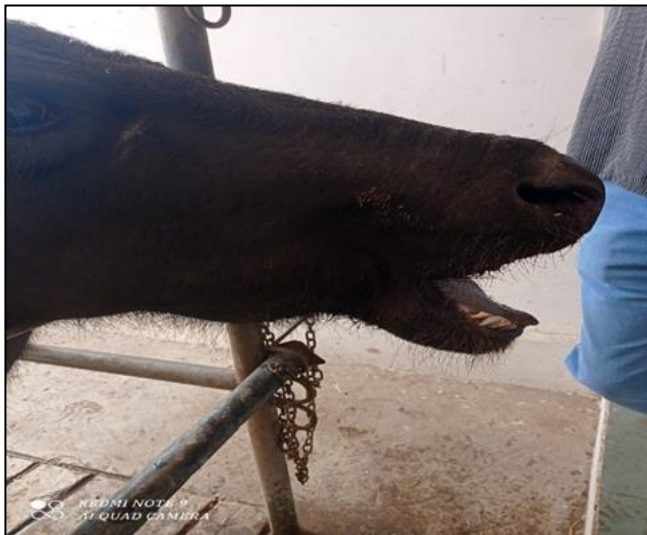
Fig 1: Bilateral mandibular fracture in buffalo

A 4 years old, 270 kg Mehsana buffalo was presented to Department of Veterinary Surgery and Radiology, College of Veterinary Science & A. H., KU, Sardarkrushinagar with a history of difficulty in feeding, hanging of lower jaw incisor after knocking of head against bike during accident. On clinical examination, rectal temperature was 99.4⁰F, the heart rate was 64 beats /min and the respiration rate was 28 breaths/ min. Upon examination of oral cavity, left side mucosa was tear near 1st molar along with abnormal motility of lower jaw and fracture fragment was noticed at proximal one-third of horizontal ramus, while right side mucosa was intact with closed fractures of right horizontal ramus (fig.1). Upon palpation, pain and crepitation was exhibited by animal. The haematological parameters were within normal range. Radiographic examination of horizontal ramus of mandible was performed in latero-medial and rostro-caudal position using computed radiography. The case was confirmed as complete bilateral fracture of mandible.

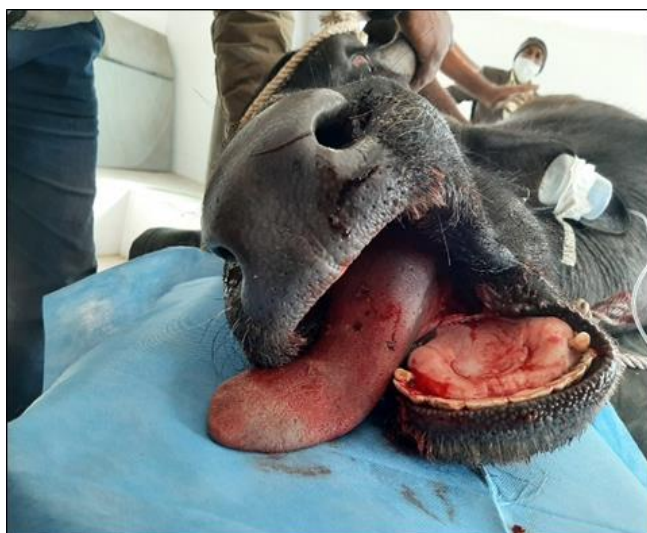
Fig 2: Restrain in lateral recumbency for intramedullary pinning

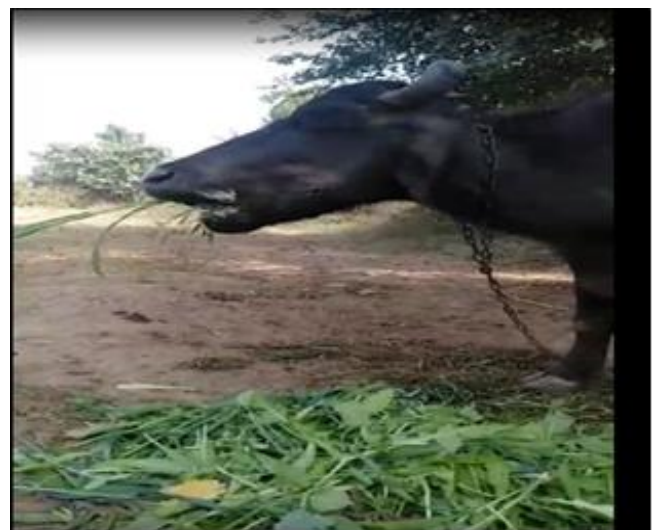
Fig 5: Normal feeding after 21st Post-operative day
